Wildwood POA
Village Mills , TX

Report #: 42715-0
Beginning: January 1, 2022
Expires: December 31, 2022

RESERVE STUDY
"Full"

January 25, 2022

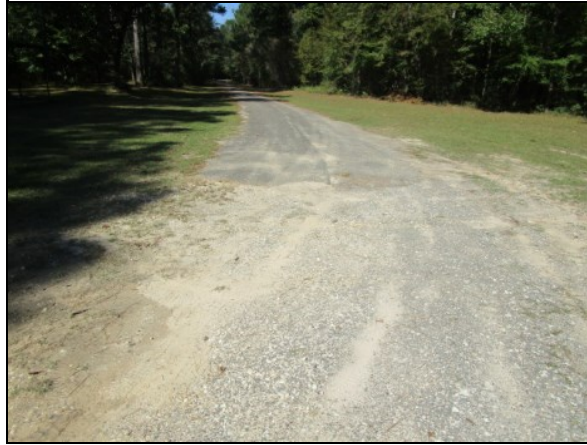
Useful Life:
30 years

Remaining Life:
7 years

Best Case: \$ 650,000

Worst Case: \$ 700,000

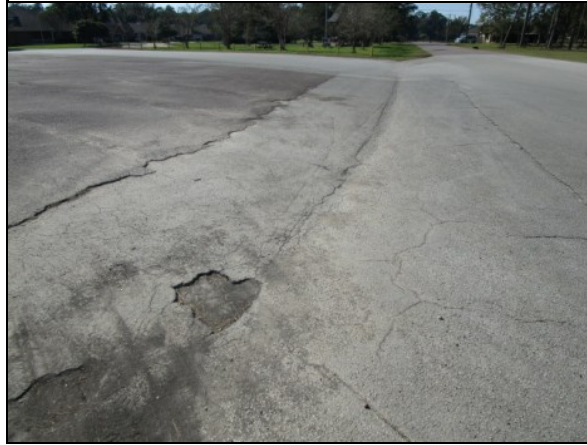
Useful Life:
30 years

Remaining Life:
17 years

Best Case: \$ 2,700,000

Worst Case: \$ 2,750,000

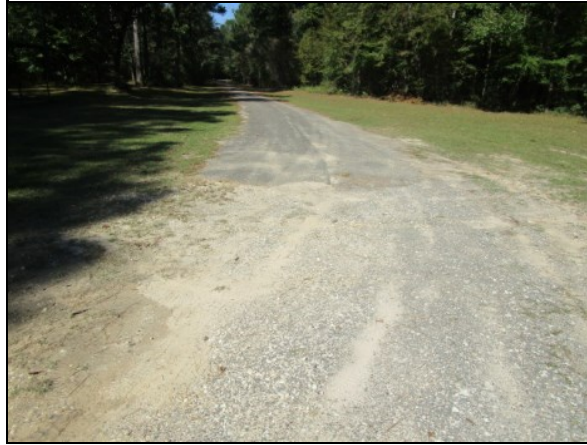
Useful Life:
5 years

Remaining Life:
2 years

Best Case: \$ 66,000

Worst Case: \$ 70,000

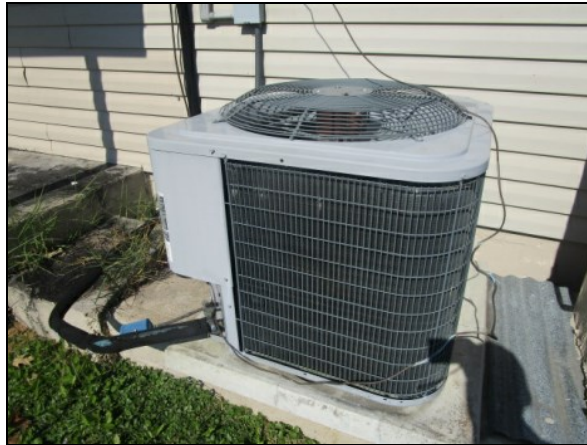
Life expectancy of HVAC systems can vary greatly depending on many factors including location of the property, level of preventive maintenance, manufacturer, technology/efficiency improvements, etc. We recommend that routine repairs and maintenance such as filter replacements, system flushing, etc. be budgeted as an Operating expense. Useful life can often be extended with proactive service and maintenance. Unless otherwise noted, funding for system with same size/capacity as the current system. For split systems, we recommend budgeting to replace the entire system (condensing unit and air handler) together in order to obtain better unit pricing and ensure maximum efficiency, refrigerant compatibility, etc. If additional costs are expected during replacement, such as for system reconfiguration or expansion, ductwork repairs, electrical work, etc. costs should be re-evaluated and adjusted as needed during future Reserve Study updates.

Useful Life:
15 yearsRemaining Life:
6 years

Best Case: \$ 7,000

Worst Case: \$ 9,000

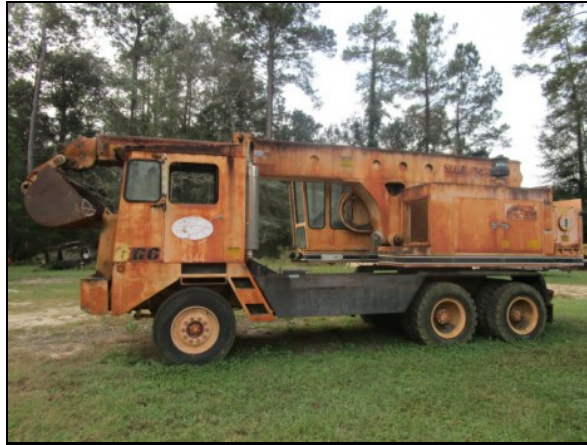
Useful Life:
20 years

Remaining Life:
0 years

Best Case: \$ 50,000

Worst Case: \$ 100,000

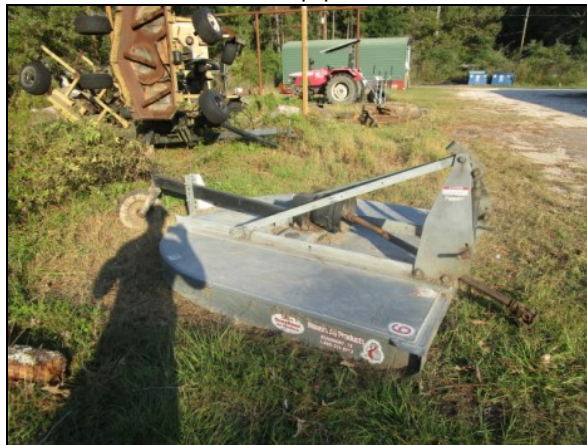
Useful Life:
10 years

Remaining Life:
0 years

Best Case: \$ 2,500

Worst Case: \$ 3,500
