Wildwood POA
Village Mills , TX

Report #: 42715-0
Beginning: January 1, 2022
Expires: December 31, 2022

RESERVE STUDY
"Full"

January 25, 2022

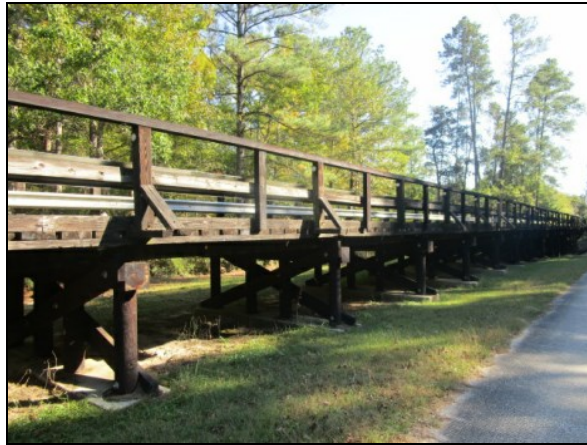
Comp #: 1701 Vehicle Bridge - Repair/Replace

Comments: Bridge structures determined to be in good condition typically exhibit little to no signs of instability or significant wear to structural framework beneath the exposed decking. No apparent sagging, twisting, or other advanced deterioration.

Assuming normal wear and tear and good preventive maintenance, complete replacement or reconstruction may be required at longer intervals, including some or all components of structural framework, pilings, etc. If present, reconstruction may also need to include replacement of electrical infrastructure or other features. In our experience, all such projects are unique, and we strongly recommend consulting with engineers or experienced contractors to properly determine existing conditions and required scope of work. Our inspection is visual only and limited to accessible areas, and does not incorporate any specific testing or thorough structural evaluation. Life and cost estimates shown here are intended for planning and budgeting purposes, and may need to be re-evaluated in light of any more thorough analysis or other outside information.

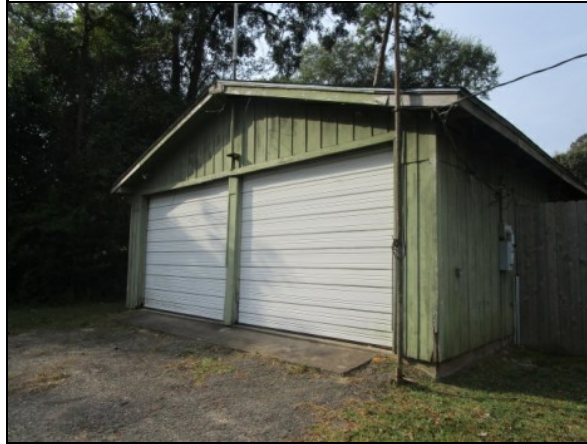
The building exteriors are in fair to poor condition. Perimeter wood fencing is in good condition. No issues reported. Funding provided for periodic refurbishments following the schedule below.

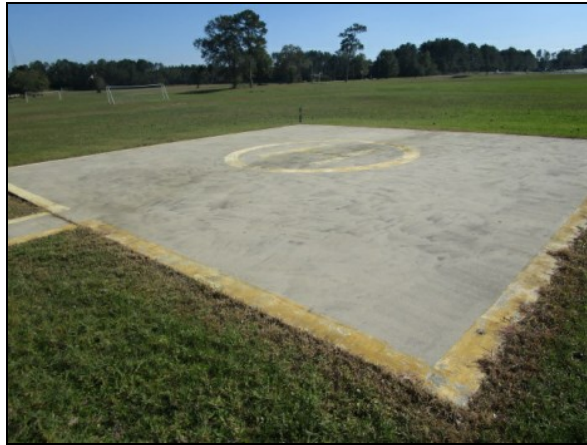
Comp #: 1999 Helipad - Replace

Comments: The concrete surfaces are in fair condition at this time. Best to inspect on a regular basis. Funding provided for replacement following the schedule below.

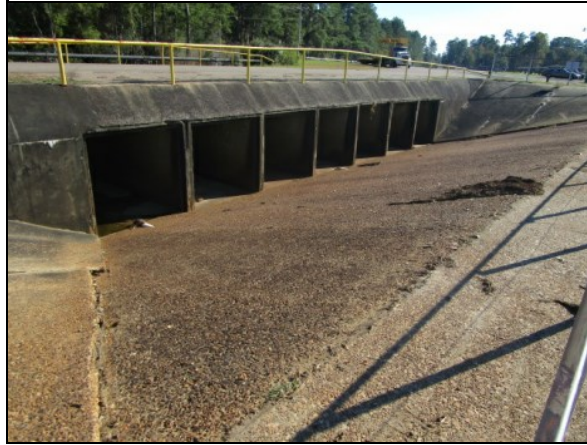
Comp #: 2000 Concrete Dam/Spillway - Repair

Comments: The dams are in fair condition. Best to have inspected on a regular basis by a licensed service provider. Funding provided for periodic repairs.

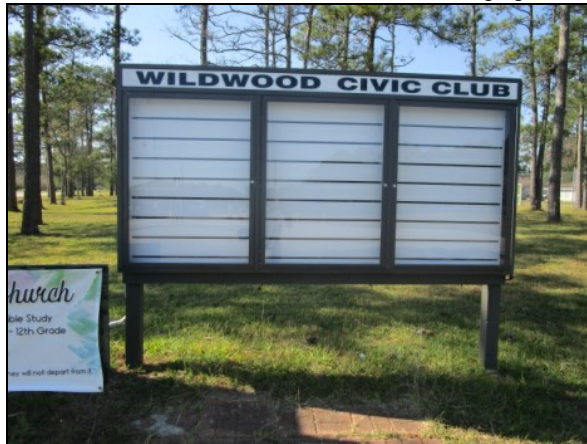
Comp #: 2001 Marquees - Replace

Comments: The marquees are in fair condition at this time. Moderate wear and aging observed. Expect a full useful life.

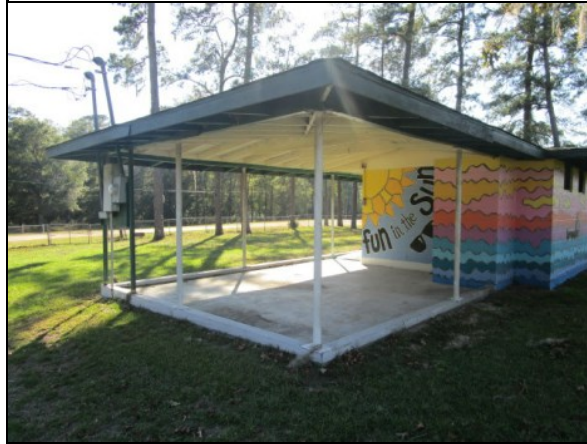
The building envelops in good condition. Painted surfaces are vibrant and attractive. Funding provided for periodic refurbishments.

Comments: Refurbishments include replacement of roofing surfaces and exterior rehab including painting and repairs.

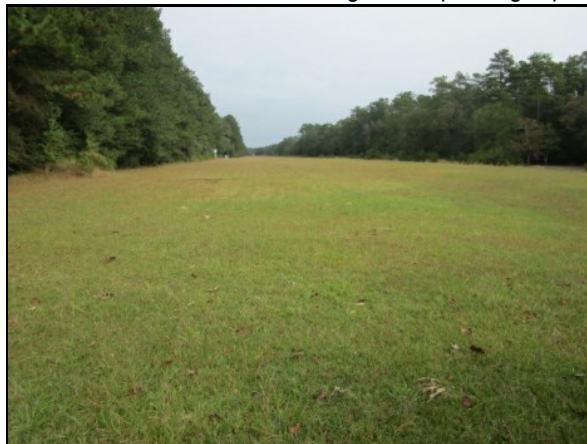
Comments: The runway is in good condition. Best to maintain as a general operating expense. No reserve funding required.

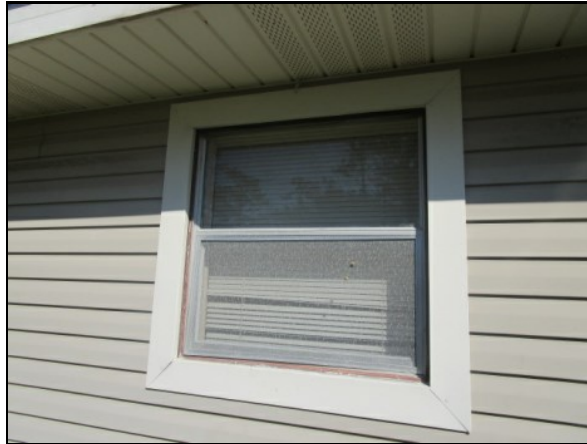
Comp #: 703 Windows & Doors - Replace

Comments: Windows and doors determined to be in fair condition typically exhibit normal signs of wear for their age, including more surface wear to framework and hardware, but no advanced corrosion or other concerns. At this stage, windows and doors are believed to be functional and aging normally, but more advanced technology may be available.

Unless otherwise noted, this component refers only to exterior windows and doors. All are assumed to have been compliant with applicable building codes at time of installation. Inspect regularly for leaks and cracks around frame and repair as needed. For operable windows, clean tracks and ensure hardware is functional to prevent accidental damage during opening/closing. With ordinary care and maintenance, useful life is typically long but often difficult to predict. Many factors affect useful life including quality of window currently installed, waterproofing details, exposure to wind and rain, etc. Individual windows and doors should be replaced as an Operating expense if damaged or broken. Plan for comprehensive replacement of all areas (unless otherwise noted) at the approximate interval shown here. Costs are based on replacement with good quality, impact-resistant models.

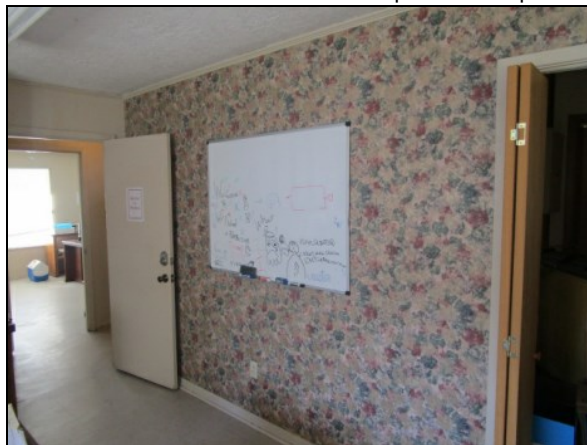
The interiors are dated but still in fair condition. An allowance has been provided for periodic refurbishments.

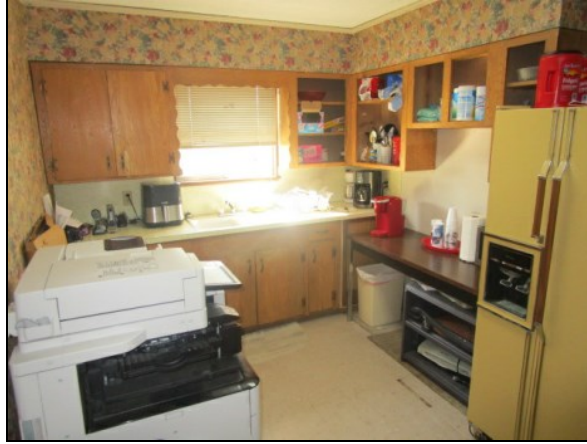
The interiors are in fair and declining condition. Cabinetry, flooring, and other surfaces are dated. Funding provided for future remodeling efforts.

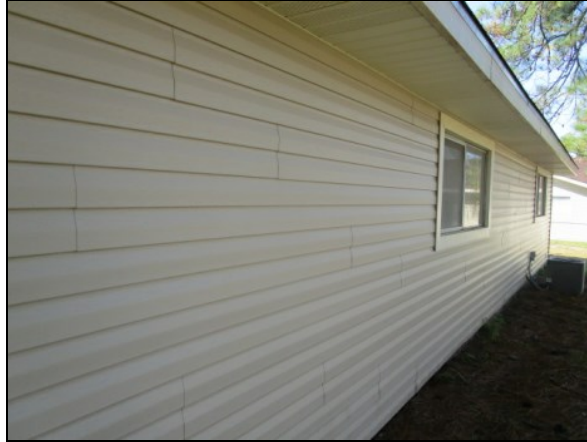
Comp #: 1120 Vinyl Siding - Replace

Comments: Vinyl siding determined to be in fair condition typically exhibits minor to moderate fading of color, and typically has more surface wear and cracking, especially in more exposed areas/elevations. Some curling/cupping of individual sections may be evident.

No view of the underlying waterproofing was undertaken as part of this limited visual review. In our experience, vinyl siding will fade over the years and when replacing pieces, it may be difficult to match the faded color. The useful life expectancy shown below is for financial planning purposes only. We recommend that the Client consult with a qualified contractor/engineer to evaluate the siding, and the critical underlying waterproofing (building paper or house wrap) as the remaining useful life approaches zero. In some cases, remaining useful life extension may be warranted based on the evaluation of performance of the underlying waterproofing. Cost estimates shown here assume that siding will be replaced with a similar vinyl material again. If other siding types are considered for replacement, the Reserve Study should be updated accordingly during future update engagements to incorporate the most current estimates and information available at that time.

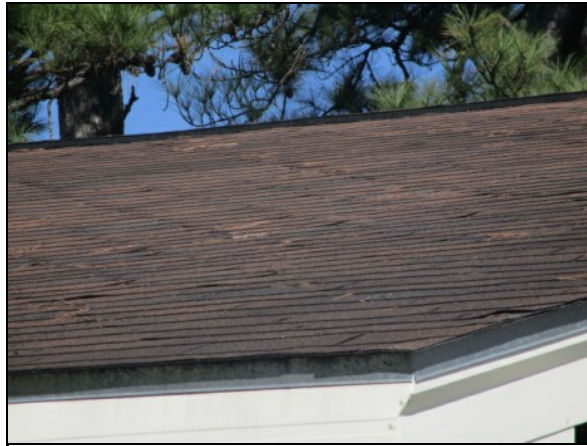
Comp #: 1303 Asphalt Shingle Roof - Replace

Comments: Asphalt shingle roofs determined to be in fair condition typically exhibit normal signs of wear and deterioration, including some loss of granule cover, and light to moderate curling/lifting, especially in most exposed areas. Overall believed to be aging normally.

As routine maintenance, many manufacturers recommend inspections at least twice annually and after large storm events. Promptly replace any damaged/missing sections or conduct any other repair needed to ensure waterproof integrity of roof. Keep roof surface, gutters and downspouts clear and free of moss or debris. Moss growth can decrease the life of the roofing shingles and should be removed promptly. We recommend having roof inspected in greater detail (including conditions of sub-surface materials) by an independent roofing consultant prior to replacement. There is a wealth of information available through organizations such as the Roof Consultant Institute <http://www.rci-online.org/> and the National Roofing Contractors Assn. (NRCA) <http://www.nrca.net/>. If the roof has a warranty, be sure to review terms and conduct proper inspections/repairs as needed to keep warranty in force. Dimensional shingles typically have longer useful lives and are generally considered to be more valuable from an aesthetic standpoint. We recommend budgeting to replace with dimensional shingles upon failure. Also known as architectural shingles, these types of roofs are typically more durable and wind-resistant than 3-tab shingles. Remaining useful life is based on consideration of installation/replacement date, evident visual conditions, and/or repair history provided by the Client. Unless otherwise noted, costs shown here assume that only a minimal amount of substrate/decking repairs or replacement will be required. For very old roofs or those with significant leak problems, additional repair costs may be incurred.

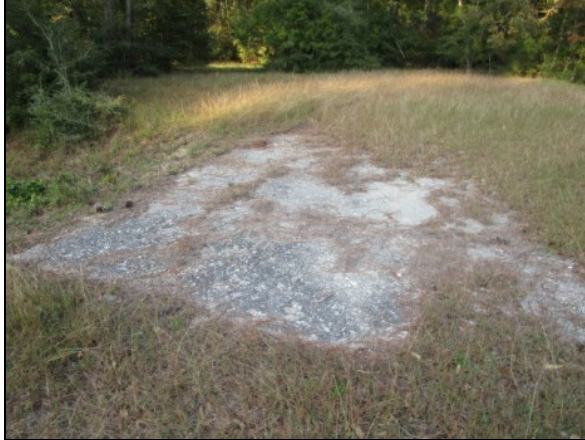
Comp #: 209 Camping Pads - Replace**Quantity: (17) of (34) Pads**

Comments: The RV pads are in poor condition. Funding provided for resurfacing these areas so a new substrate can be laid. Funding provided for an asphalt surface.

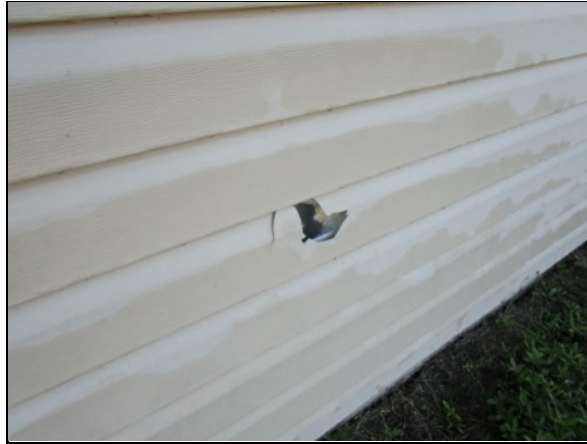
Comp #: 1120 Vinyl Siding - Replace

Comments: Vinyl siding determined to be in fair condition typically exhibits minor to moderate fading of color, and typically has more surface wear and cracking, especially in more exposed areas/elevations. Some curling/cupping of individual sections may be evident. Local areas of cracking and damage observed.

No view of the underlying waterproofing was undertaken as part of this limited visual review. In our experience, vinyl siding will fade over the years and when replacing pieces, it may be difficult to match the faded color. The useful life expectancy shown below is for financial planning purposes only. We recommend that the Client consult with a qualified contractor/engineer to evaluate the siding, and the critical underlying waterproofing (building paper or house wrap) as the remaining useful life approaches zero. In some cases, remaining useful life extension may be warranted based on the evaluation of performance of the underlying waterproofing. Cost estimates shown here assume that siding will be replaced with a similar vinyl material again. If other siding types are considered for replacement, the Reserve Study should be updated accordingly during future update engagements to incorporate the most current estimates and information available at that time.

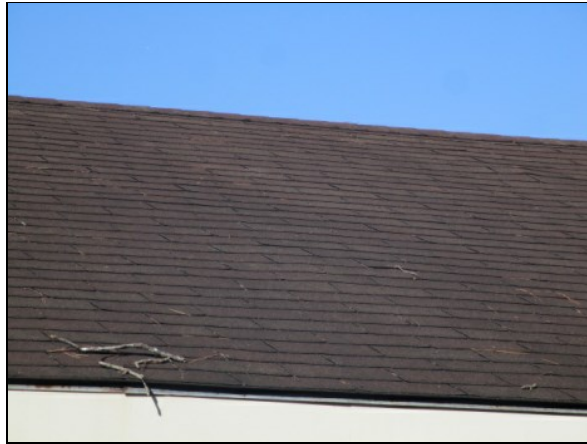
Comp #: 1303 Asphalt Shingle Roof (A) - Replace

Comments: Asphalt shingle roofs determined to be in fair condition typically exhibit normal signs of wear and deterioration, including some loss of granule cover, and light to moderate curling/lifting, especially in most exposed areas. Overall believed to be aging normally.

As routine maintenance, many manufacturers recommend inspections at least twice annually and after large storm events. Promptly replace any damaged/missing sections or conduct any other repair needed to ensure waterproof integrity of roof. Keep roof surface, gutters and downspouts clear and free of moss or debris. Moss growth can decrease the life of the roofing shingles and should be removed promptly. We recommend having roof inspected in greater detail (including conditions of sub-surface materials) by an independent roofing consultant prior to replacement. There is a wealth of information available through organizations such as the Roof Consultant Institute <http://www.rci-online.org/> and the National Roofing Contractors Assn. (NRCA) <http://www.nrca.net/>. If the roof has a warranty, be sure to review terms and conduct proper inspections/repairs as needed to keep warranty in force. Dimensional shingles typically have longer useful lives and are generally considered to be more valuable from an aesthetic standpoint. We recommend budgeting to replace with dimensional shingles upon failure. Also known as architectural shingles, these types of roofs are typically more durable and wind-resistant than 3-tab shingles. Remaining useful life is based on consideration of installation/replacement date, evident visual conditions, and/or repair history provided by the Client. Unless otherwise noted, costs shown here assume that only a minimal amount of substrate/decking repairs or replacement will be required. For very old roofs or those with significant leak problems, additional repair costs may be incurred.

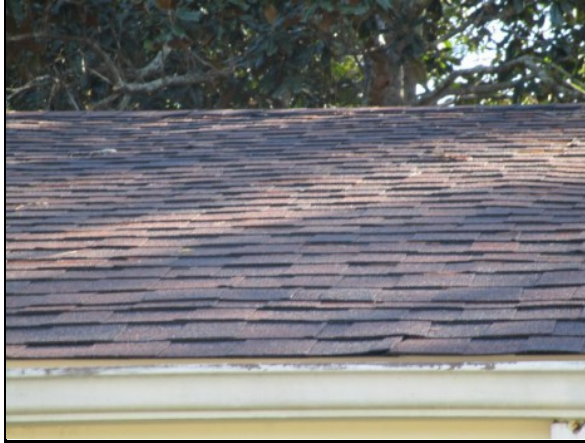
Comp #: 1303 Asphalt Shingle Roof (B) - Replace

Comments: Asphalt shingle roofs determined to be in good condition typically exhibit few or no signs of curling/cupping of shingles, and granule cover appears to be thick and consistent. Little to no organic growth or staining patterns evident, and no unusual or significant leaks reported. Shingles and flashing appear to provide good coverage to all areas, especially at intersection points and around any penetrations.

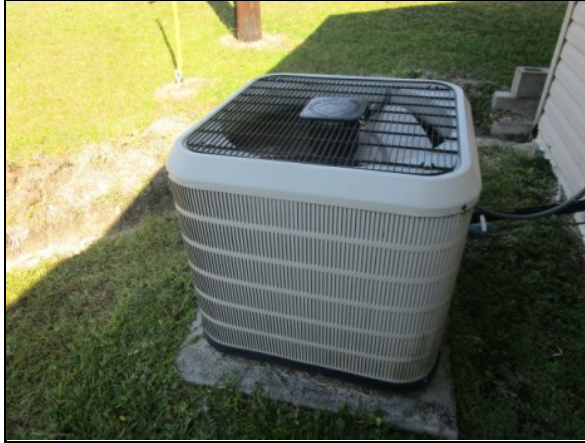
Comp #: 303 HVAC Unit (2011) - Replace

Refer to prior HVAC component(s) for additional general information regarding HVAC replacement guidelines. Plan to replace this system at the approximate interval shown here.

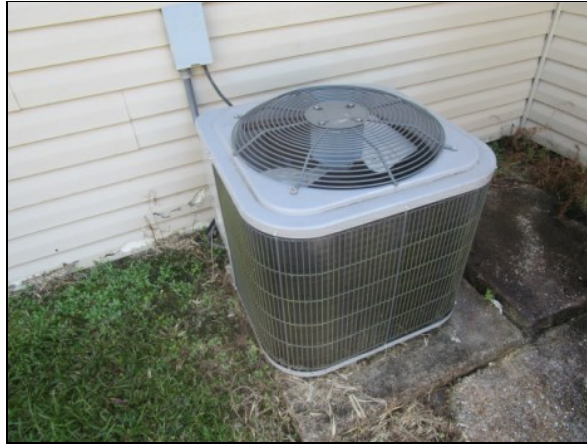
Comp #: 303 HVAC Unit (2018) - Replace

Life expectancy of HVAC systems can vary greatly depending on many factors including location of the property, level of preventive maintenance, manufacturer, technology/efficiency improvements, etc. We recommend that routine repairs and maintenance such as filter replacements, system flushing, etc. be budgeted as an Operating expense. Useful life can often be extended with proactive service and maintenance. Unless otherwise noted, funding for system with same size/capacity as the current system. For split systems, we recommend budgeting to replace the entire system (condensing unit and air handler) together in order to obtain better unit pricing and ensure maximum efficiency, refrigerant compatibility, etc. If additional costs are expected during replacement, such as for system reconfiguration or expansion, ductwork repairs, electrical work, etc. costs should be re-evaluated and adjusted as needed during future Reserve Study updates.

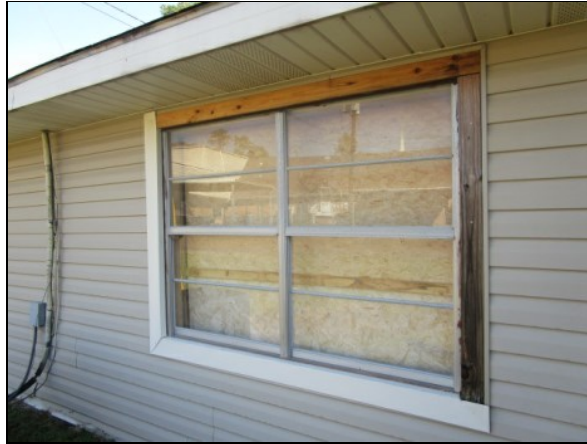
Comp #: 703 Windows & Doors - Replace

Comments: Windows and doors determined to be in fair condition typically exhibit normal signs of wear for their age, including more surface wear to framework and hardware, but no advanced corrosion or other concerns. At this stage, windows and doors are believed to be functional and aging normally, but more advanced technology may be available.

Unless otherwise noted, this component refers only to exterior windows and doors. All are assumed to have been compliant with applicable building codes at time of installation. Inspect regularly for leaks and cracks around frame and repair as needed. For operable windows, clean tracks and ensure hardware is functional to prevent accidental damage during opening/closing. With ordinary care and maintenance, useful life is typically long but often difficult to predict. Many factors affect useful life including quality of window currently installed, waterproofing details, exposure to wind and rain, etc. Individual windows and doors should be replaced as an Operating expense if damaged or broken. Plan for comprehensive replacement of all areas (unless otherwise noted) at the approximate interval shown here. Costs are based on replacement with good quality, impact-resistant models.

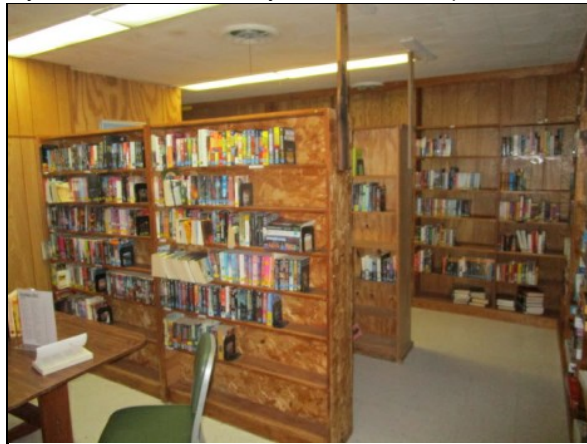
Interior areas determined to be in fair condition typically exhibit some minor, routine marks and scuffs, small sections of peeling paint, etc. Overall appearance is satisfactory.

Regular cycles of professional painting are recommended to maintain appearance. Small touch-up projects can be conducted as needed as a maintenance expense, but comprehensive painting of interior areas will restore a consistent look and quality to all areas. Best practice is to coordinate at same time as other interior projects (flooring, furnishings, lighting, etc.) whenever possible to minimize downtime and maintain consistent quality standard. Based on evident conditions and/or project history provided during this engagement, we recommend repainting at the approximate interval shown below. Unless otherwise noted, cost estimates below are intended for painting only and not inclusive of any extensive wall repairs/renovations (such as trim work, etc.).

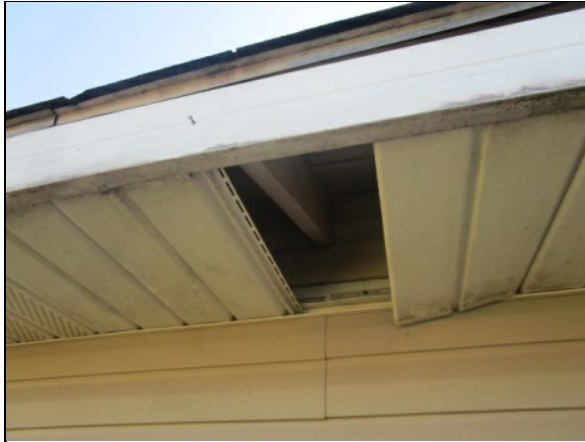
Comp #: 1120 Vinyl Siding - Replace

Comments: Vinyl siding determined to be in fair condition typically exhibits minor to moderate fading of color, and typically has more surface wear and cracking, especially in more exposed areas/elevations. Some curling/cupping of individual sections may be evident.

No view of the underlying waterproofing was undertaken as part of this limited visual review. In our experience, vinyl siding will fade over the years and when replacing pieces, it may be difficult to match the faded color. The useful life expectancy shown below is for financial planning purposes only. We recommend that the Client consult with a qualified contractor/engineer to evaluate the siding, and the critical underlying waterproofing (building paper or house wrap) as the remaining useful life approaches zero. In some cases, remaining useful life extension may be warranted based on the evaluation of performance of the underlying waterproofing. Cost estimates shown here assume that siding will be replaced with a similar vinyl material again. If other siding types are considered for replacement, the Reserve Study should be updated accordingly during future update engagements to incorporate the most current estimates and information available at that time.

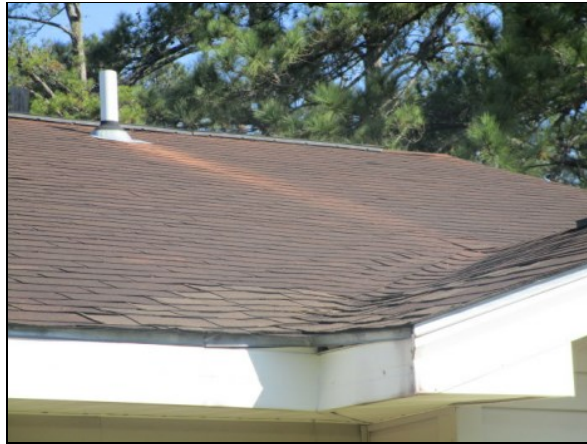
Comp #: 1303 Asphalt Shingle Roof - Replace

Comments: Asphalt shingle roofs determined to be in fair condition typically exhibit normal signs of wear and deterioration, including some loss of granule cover, and light to moderate curling/lifting, especially in most exposed areas. Overall believed to be aging normally.

As routine maintenance, many manufacturers recommend inspections at least twice annually and after large storm events. Promptly replace any damaged/missing sections or conduct any other repair needed to ensure waterproof integrity of roof. Keep roof surface, gutters and downspouts clear and free of moss or debris. Moss growth can decrease the life of the roofing shingles and should be removed promptly. We recommend having roof inspected in greater detail (including conditions of sub-surface materials) by an independent roofing consultant prior to replacement. There is a wealth of information available through organizations such as the Roof Consultant Institute <http://www.rci-online.org/> and the National Roofing Contractors Assn. (NRCA) <http://www.nrca.net/>. If the roof has a warranty, be sure to review terms and conduct proper inspections/repairs as needed to keep warranty in force. Dimensional shingles typically have longer useful lives and are generally considered to be more valuable from an aesthetic standpoint. We recommend budgeting to replace with dimensional shingles upon failure. Also known as architectural shingles, these types of roofs are typically more durable and wind-resistant than 3-tab shingles. Remaining useful life is based on consideration of installation/replacement date, evident visual conditions, and/or repair history provided by the Client. Unless otherwise noted, costs shown here assume that only a minimal amount of substrate/decking repairs or replacement will be required. For very old roofs or those with significant leak problems, additional repair costs may be incurred.

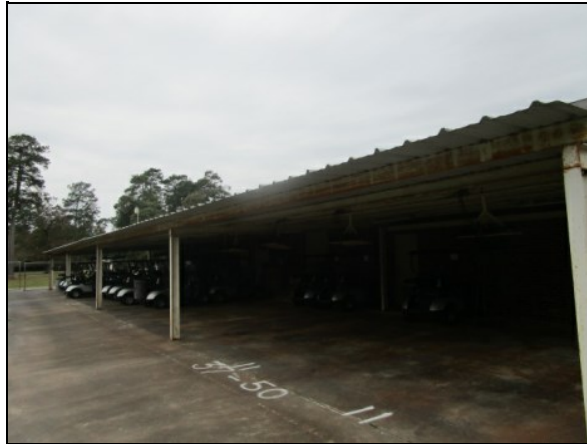
Comp #: 1308 Metal Seam Roof - Replace

Comments: Roof is in good condition at this time.

The timeline for metal roof replacement is generally estimated based on the age of the roof. Remaining useful life can also be adjusted based on inspection of any accessible areas, looking for any damaged or lifting sections, signs of advanced corrosion or wear to panels and hardware, as well as consultation with the client about history of repairs and preventive maintenance. Advantages of metal roofs include long life expectancies with relatively low need to repair. Metal roofing is typically a long-lived component assuming it was properly installed and is properly maintained. As routine maintenance, many manufacturers recommend inspections at least twice annually and after large storm events. Promptly replace any damaged/missing sections or conduct any other repair needed to ensure waterproof integrity of roof. We recommend having roof inspected in greater detail (including conditions of sub-surface materials) by an independent roofing consultant prior to replacement. There is a wealth of information available through organizations such as the Roof Consultant Institute <http://www.rci-online.org/> and the National Roofing Contractors Association (NRCA) <http://www.nrca.net/>. If the roof has a warranty, be sure to review terms and conduct proper inspections/repairs as needed to keep warranty in force.

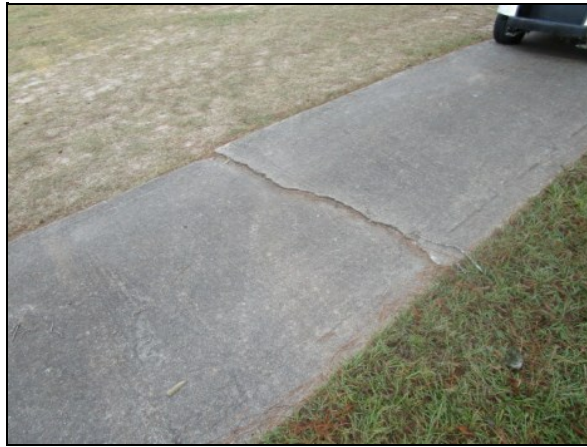
Comp #: 103 Golf Cart Path - Repair/Maintain

Comments: Funding provided to repair 2% of the concrete surfaces.

Concrete sidewalks determined to be in fair condition typically exhibit minor changes in slope and a moderate percentage of cracking and surface wear. Trip hazards may be increasing in frequency and severity and should be closely monitored to prevent further risks.

Repair any trip and fall hazards immediately to ensure safety. As routine maintenance, inspect regularly, pressure wash for appearance and repair promptly as needed to prevent water penetrating into the base and causing further damage. In our experience, larger repair/replacement expenses emerge as the community ages, especially as trees adjacent to sidewalks continue to grow. Although difficult to predict timing, cost and scope, we suggest a rotating funding allowance to supplement the operating/maintenance budget for periodic larger repairs. Adjust as conditions, actual expense patterns dictate within future Reserve Study updates.

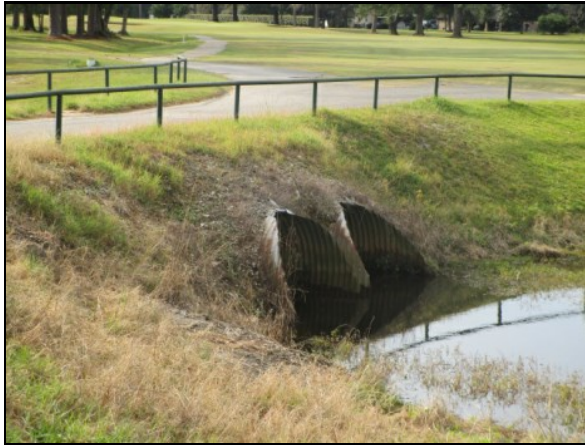
Comp #: 120 Site Drainage System – Clean/Repair

Comments: As this was a visual inspection only, there was no access nor capability to inspect in-ground drainage infrastructure comprehensively. Annual preventive maintenance work is typically performed as part of a Client's general maintenance/operating fund. Under normal circumstances, site drainage components are constructed of very durable materials which should have a very long useful life (often assumed to be 50 years or more). Repairs may occasionally be required, but timing and scope of potential work has been deemed to be too unpredictable for Reserve funding at this time (in accordance with National Reserve Study Standards). If there are specific, known concerns with drainage system, we recommend further investigation using cameras or other means to document and identify conditions. Some Clients consult with civil and/or geotechnical engineers in order to develop scopes of work for repair/replacement. If more comprehensive analysis becomes available, findings should be incorporated into Reserve Study updates as appropriate.

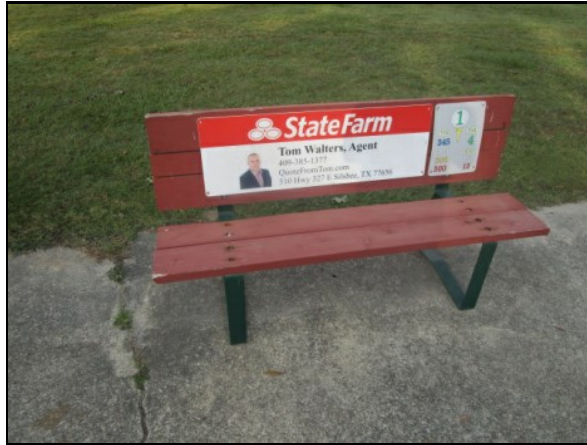
Comp #: 406 Benches - Replace

Comments: Outdoor/site furniture determined to be in good condition typically exhibits little to no significant signs of wear or age. Style is attractive and appropriate for the local aesthetic standards of the development.

Inspect regularly, clean for appearance and repair as needed from general Operating funds. Cost to replace individual pieces may not meet threshold for Reserve funding. We recommend planning for regular intervals of complete replacement at the time frame indicated below, to maintain a good, consistent appearance in the common areas. Costs shown are based on replacement with comparable types unless otherwise noted.

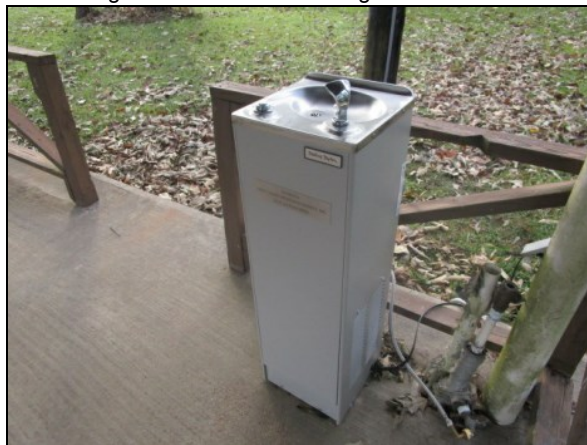
Comp #: 411 Drinking Fountains - Replace

Comments: The drinking fountains were in good condition. No damage or corrosion noted. Expect a full useful life.

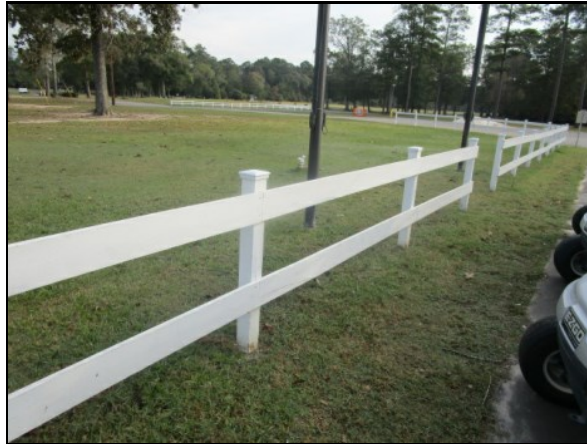
Comp #: 505 Wood Fence (Split Rail) - Replace

Comments: Wood fencing determined to be in good physical/structural condition is stable and upright, with no signs or reports of damage or required repairs. All components and hardware appear to be in serviceable condition with no unusual or advanced signs of wear or age. Fencing is in good aesthetic condition.

As routine maintenance, inspect regularly for any damage, repair as needed and avoid contact with ground and surrounding vegetation wherever possible. Regular cycles of uniform, professional sealing/painting will help to maintain appearance and maximize life. In our experience, wood fencing will typically eventually break down due to a combination of sun and weather exposure, which is sometimes exacerbated by other factors such as irrigation overspray, abuse and lack of preventive maintenance. Recommendation and costs shown here are based on replacement with similar style and material. However, the Association might want to consider replacing with more sturdy, lower-maintenance products like composite, vinyl, etc. Although installation costs are higher, total life cycle cost is lower due to less maintenance and longer design life expectancy.

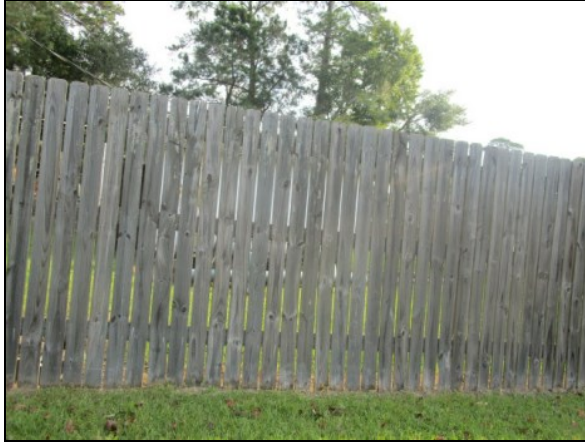
Comp #: 505 Wood Fencing - Replace

Comments: Wood fencing determined to be in fair condition typically exhibits some minor to moderate amounts of surface wear and other signs of age, which may include a small percentage of warped, split and/or rotted sections. In general, appearance is consistent but declining.

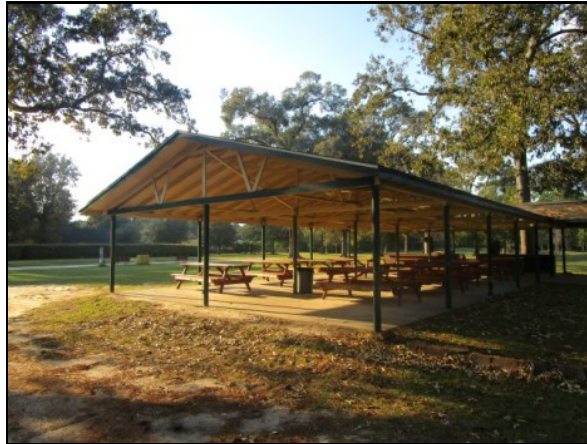
Pavilion determined to be in fair condition typically exhibit more wear and tear, possibly including some warped, split and/or deteriorated components. Framework/structure should still be sturdy but may have sections showing minor leaning or damage.

As routine maintenance, inspect regularly and repair individual pieces or sections as needed from general Operating funds. Clean and paint/stain along with other larger projects or as general maintenance to preserve the appearance of the pavilion and extend its useful life. If present, vegetation should be well-maintained and not allowed to become overgrown, which can eventually compromise the structure. Assuming ordinary care and maintenance, plan for major repairs or possibly complete replacement (if warranted) at roughly the interval indicated below.

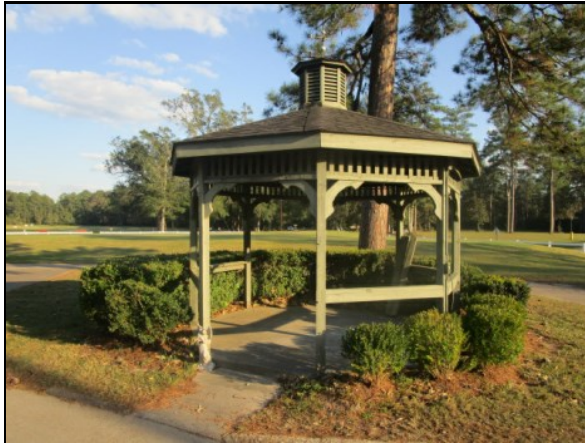
Comp #: 510 Gazebo - Refurbish/Replace

Comments: Gazebo determined to be in fair condition typically exhibit more wear and tear, possibly including some warped, split and/or deteriorated components. Framework/structure should still be sturdy but may have sections showing minor leaning or damage.

As routine maintenance, inspect regularly and repair individual pieces or sections as needed from general Operating funds. Clean and paint/stain along with other larger projects or as general maintenance to preserve the appearance of the gazebo and extend its useful life. If present, vegetation should be well-maintained and not allowed to become overgrown, which can eventually compromise the structure. Assuming ordinary care and maintenance, plan for major repairs or possibly complete replacement (if warranted) at roughly the interval indicated below.

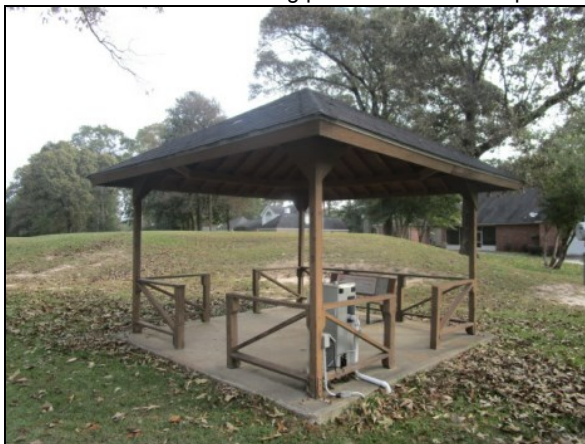
Comp #: 511 Lightning Shelters - Replace

The lightning shelters are in fair condition at this time. Funding provided for future replacement.

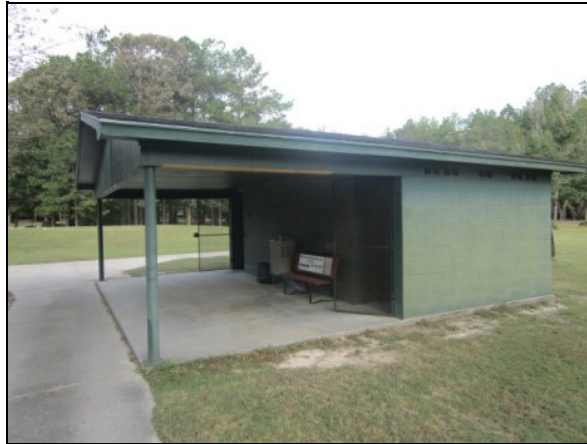
Restrooms determined to be in fair condition typically exhibit some light to moderate signs of use and age. Finishes are clean but showing some wear. All fixtures are assumed to be functional, but may be becoming outdated at this stage. Generally in serviceable condition. One of the restrooms was remodeled/refurbished by community members.

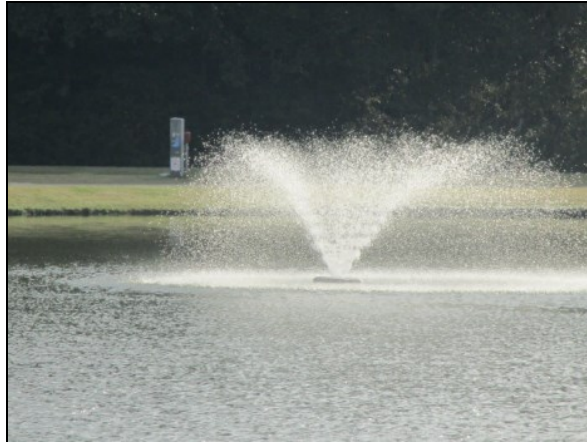
Comp #: 1007 Lake Fountains - Replace

Comments: Fountains are in good condition. No issues reported.

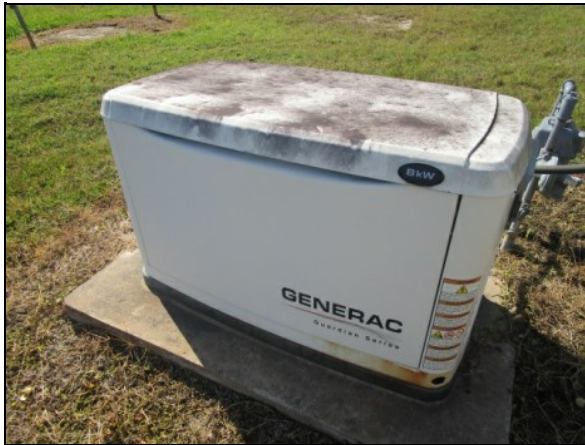
Comp #: 302 Generator (Generac) - Replace

Comments: Generators are a key building element in this location due to risk of severe storms and power outages, and should be tested/evaluated regularly to ensure proper function. Minimal or no subjective/aesthetic value for this component. Useful life is based primarily on normal expectations for service/performance life in this location. Vendors typically report that with ongoing maintenance (e.g. fluids, batteries, tune ups), useful life can be extended for many years. However, funding for complete replacement is often warranted due to lack of available replacement parts rather than failure of the generator as a whole. Treat periodic service and inspect as general maintenance expense within Operating budget, not Reserves. Unless otherwise noted, remaining useful life expectancy is based primarily on original installation or last replacement/purchase date, our experience with similar systems/components, and assuming normal amount of usage and good preventive maintenance. Cost estimates shown below assume replacement with a similar size and type as currently in place. However, this component should be re-evaluated during future Reserve Study updates based on the most current information available at that time.

Useful Life:
30 years

Remaining Life:
20 years

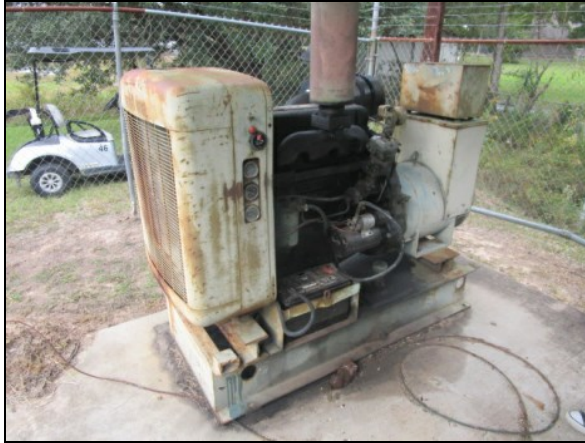
Comp #: 302 Generator (Lift Station) - Replace

Comments: Generators are a key building element in this location due to risk of severe storms and power outages, and should be tested/evaluated regularly to ensure proper function. Minimal or no subjective/aesthetic value for this component. Useful life is based primarily on normal expectations for service/performance life in this location. Vendors typically report that with ongoing maintenance (e.g. fluids, batteries, tune ups), useful life can be extended for many years. However, funding for complete replacement is often warranted due to lack of available replacement parts rather than failure of the generator as a whole. Treat periodic service and inspect as general maintenance expense within Operating budget, not Reserves. Unless otherwise noted, remaining useful life expectancy is based primarily on original installation or last replacement/purchase date, our experience with similar systems/components, and assuming normal amount of usage and good preventive maintenance. Cost estimates shown below assume replacement with a similar size and type as currently in place. However, this component should be re-evaluated during future Reserve Study updates based on the most current information available at that time.

Useful Life:
30 years

Remaining Life:
0 years

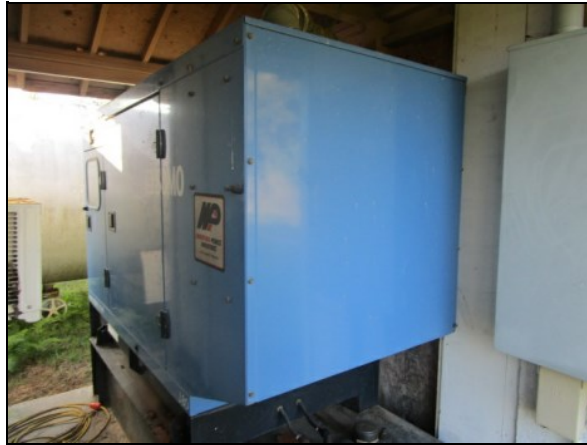
Comp #: 302 Generator (WPI) - Replace

Generator is intact and in fair condition.

Generators are a key building element in this location due to risk of severe storms and power outages, and should be tested and evaluated regularly to ensure proper function. Minimal or no subjective/aesthetic value for this component. Useful life is based primarily on normal expectations for service/performance life in this location. Vendors typically report that with ongoing maintenance (e.g. fluids, batteries, tune ups), useful life can be extended for many years. However, funding for complete replacement is often warranted due to lack of available replacement parts rather than failure of the generator as a whole. Treat periodic service and inspect as general maintenance expense within Operating budget, not Reserves. Unless otherwise noted, remaining useful life expectancy is based primarily on original installation or last replacement/purchase date, our experience with similar systems/components, and assuming normal amount of usage and good preventive maintenance. Cost estimates shown below assume replacement with a similar size and type as currently in place. However, this component should be re-evaluated during future Reserve Study updates based on the most current information available at that time.

Useful Life:
30 years

Remaining Life:
13 years

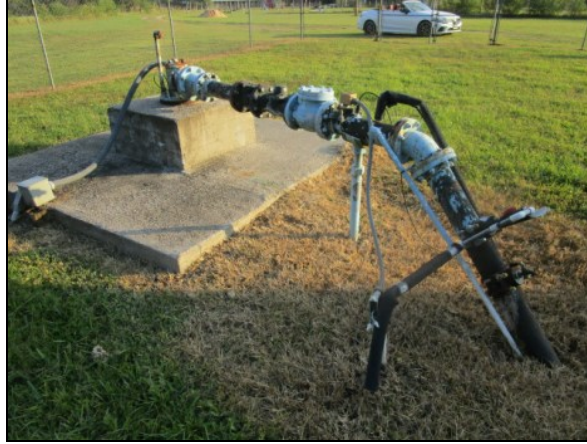
Comments: The wells were not tested during inspection. No reported issues at this time. Best to have well system inspected and maintained on a regular basis. Over time the well system will need to be refurbished. Refurbishment typically includes but is not limited to well pump replacement, expansion tank replacement, controller replacement, and projects to restore flow and debris removal. Projects should be tracked and reported to your reserve specialist. Funding provided to refurbish well following roughly the schedule below.

Useful Life:
15 years

Remaining Life:
5 years

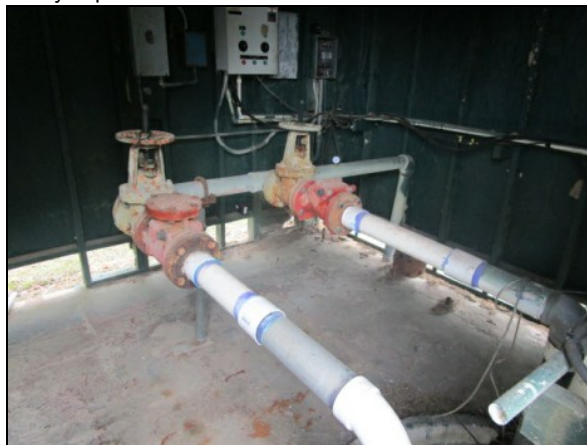
Comments: No access to directly inspect pumps to verify sizes. Make sure to inspect, test and repair as needed as an Operating expense to ensure maximum design life and optimize performance. Minimal or no subjective/aesthetic value for this component. Useful life is based primarily on normal expectations for service/performance life in this location. Pump motors can typically be replaced as-needed through this component or the Operating budget. At longer intervals, lift station pumps and controllers should ideally be replaced all together as one packaged system to optimize performance. Life span can vary depending on level of use, but plan to replace at the approximate interval shown below. Unless otherwise noted, remaining useful life expectancy is based primarily on original installation or last replacement/purchase date, our experience with similar systems/components, and assuming normal amount of usage and good preventive maintenance. Cost allowances shown below assume repair/replacement with similar materials that are currently in place.

Useful Life:
10 years

Remaining Life:
5 years

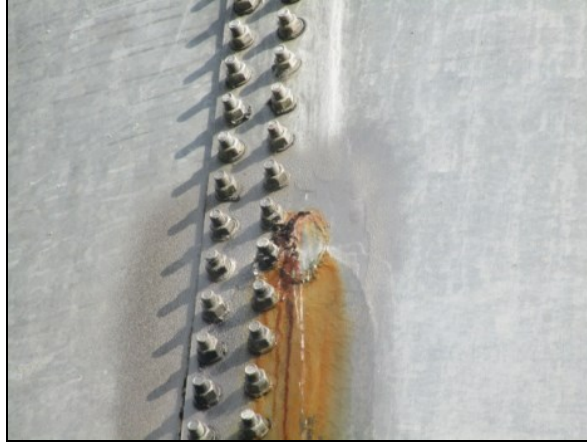
Comp #: 806 Water Storage Tank (A) - Replace

Comments: Minimal or no subjective/aesthetic value for this component. Water storage tanks should be inspected for leaks and other problems routinely by servicing vendor or maintenance staff. Small repairs and cleaning should be considered an Operating expense and conducted as needed. Plan to replace at the approximate interval shown below, ideally coordinated with replacement of the boiler/hot water heater itself in order to achieve better pricing and minimize system downtime. Unless otherwise noted, cost estimates shown below anticipate replacement with a similar size and type as currently in place.

Useful Life:
60 years

Remaining Life:
23 years

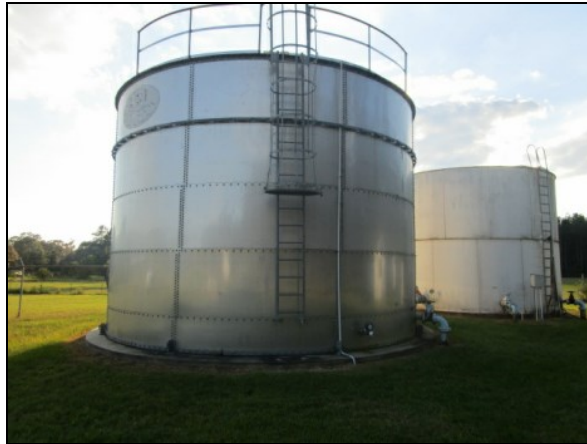
Comp #: 806 Water Storage Tanks (B) - Replace

Comments: Minimal or no subjective/aesthetic value for this component. Water storage tanks should be inspected for leaks and other problems routinely by servicing vendor or maintenance staff. Small repairs and cleaning should be considered an Operating expense and conducted as needed. Plan to replace at the approximate interval shown below, ideally coordinated with replacement of the boiler/hot water heater itself in order to achieve better pricing and minimize system downtime. Unless otherwise noted, cost estimates shown below anticipate replacement with a similar size and type as currently in place.

Useful Life:
60 years

Remaining Life:
23 years

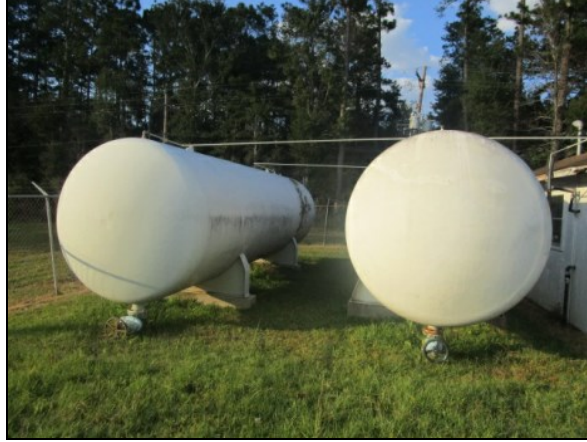
Comp #: 813 Gas Tanks - Replace

Comments: Minimal or no subjective/aesthetic value for this component. Water storage tanks should be inspected for leaks and other problems routinely by servicing vendor or maintenance staff. Small repairs and cleaning should be considered an Operating expense and conducted as needed. Plan to replace at the approximate interval shown below, ideally coordinated with replacement of the boiler/hot water heater itself in order to achieve better pricing and minimize system downtime. Unless otherwise noted, cost estimates shown below anticipate replacement with a similar size and type as currently in place.

Useful Life:
60 years

Remaining Life:
23 years

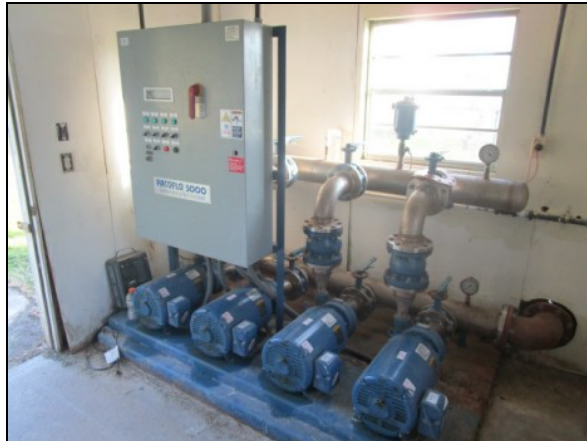
Comp #: 816 Water Booster System - Replace

Minimal or no subjective/aesthetic value for this component. Water storage tanks should be inspected for leaks and other problems routinely by servicing vendor or maintenance staff. Small repairs and cleaning should be considered an Operating expense and conducted as needed. Plan to replace at the approximate interval shown below, ideally coordinated with replacement of the boiler/hot water heater itself in order to achieve better pricing and minimize system downtime. Unless otherwise noted, cost estimates shown below anticipate replacement with a similar size and type as currently in place.

Useful Life:
20 years

Remaining Life:
10 years

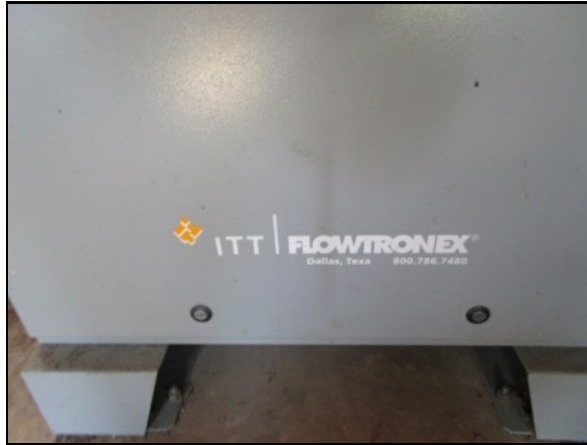
Comp #: 1009 Irrigation Sys./Controls - Replace

Comments: Irrigation timers/controllers should have a relatively long life expectancy under normal circumstances. Exposure to the elements can affect overall life expectancy, and controllers should be located in protected areas or within protective enclosures whenever possible. Replacement is often required due to lack of available replacement parts, lightning strikes, etc. as opposed to complete failure of existing equipment. Minimal or no subjective/aesthetic value for this component. Useful life is based primarily on normal expectations for service/performance life in this location. Unless otherwise noted, remaining useful life expectancy is based primarily on original installation or last replacement/purchase date, our experience with similar systems/components, and assuming normal amount of usage and good preventive maintenance. When evaluating replacement options, the Client should consider replacement with "smart" models (i.e. respond to projected weather data) to minimize unnecessary water usage. Payback period for efficient controllers that minimize water use is typically very short, easily justifying the additional costs of these options.

Useful Life:
10 years

Remaining Life:
5 years

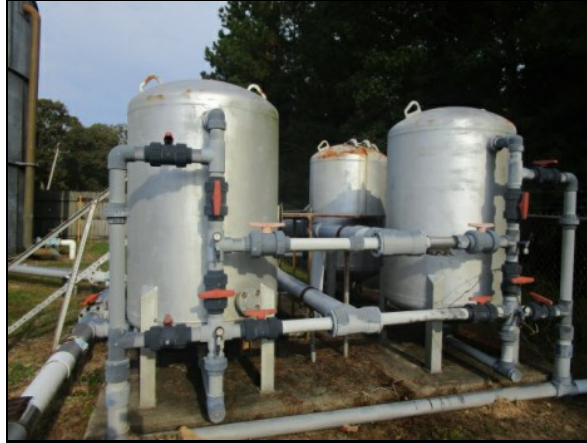
Comp #: 1010 Irrigation Equip - Replace/Maintain

Useful Life:
5 years

Remaining Life:
2 years
